# Manhole Inspection Summary

Manhole # S25II1004MH

Insp Date: **12/12/06 11:15 AM**

**Location** Address: **1130 43RD ST**

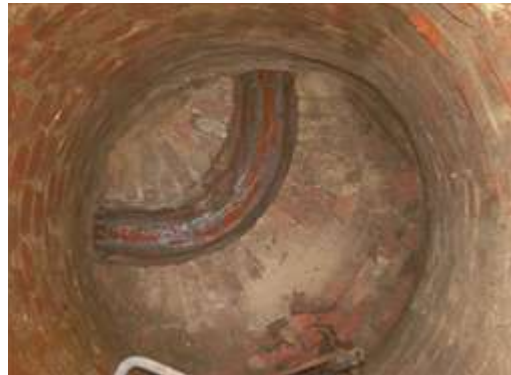
Top View

**Bench** ☒ Exists Material: **Brick** ☐ Parged ☒ **Debris** (not Condition related)

**Steps** Count: **3** Missing: **0** ☒ **Corroded**

Corroded steps. Bench debris.

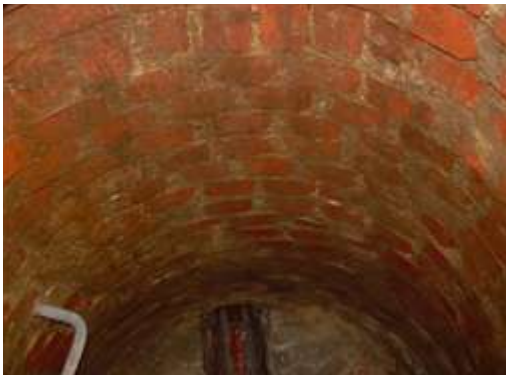
Defect

Infiltration: ☐ None ☒ **Joint** ☐ Cracks ☐ Mortar ☐ Roots ☒ **Wall**

Infiltration: ☐ None ☐ Joint ☐ Cracks ☐ Mortar ☐ Roots ☒ **Wall**

Adjustment and Barrel infiltration.

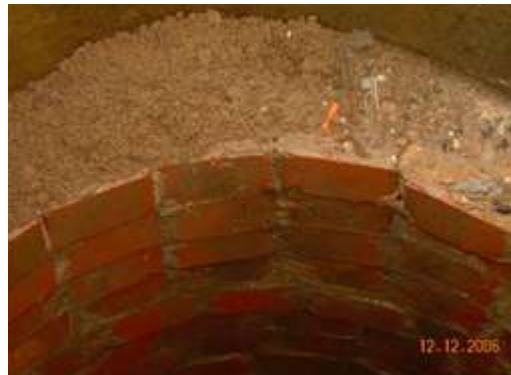
Defect

**Frame** Offset: **4** (in.) Condition: ☐ Sound ☐ Cracked ☒ **Leaks**

Frame leaks. Frame offset. Adjustment infiltration.

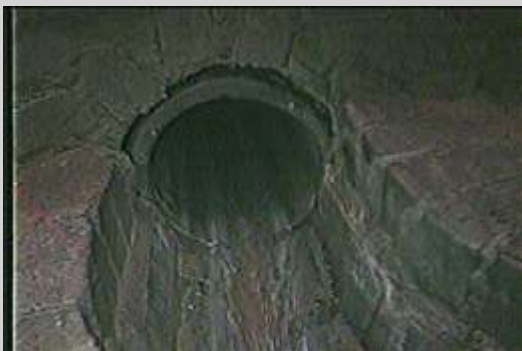
### 8 in. Circular Gravity Sewer Pipe In @ 9 O'Clock

Condition: ☐ Sound ☐ Cracked ☐ Root Intrusion ☒ **Deteriorated** ☐ Leaks ☐ Debris

Channel deterioration.

Infiltration: **Evidence** Pipe Seal Cond: **Unknown**
